Jacob's Ladder Trail Scenic Byway

Improvements Plan: Phase II

JACOB'S LADDER TRAIL SCENIC BYWAY IMPROVEMENTS PLAN: PHASE II

*Prepared by the
Pioneer Valley Planning Commission*

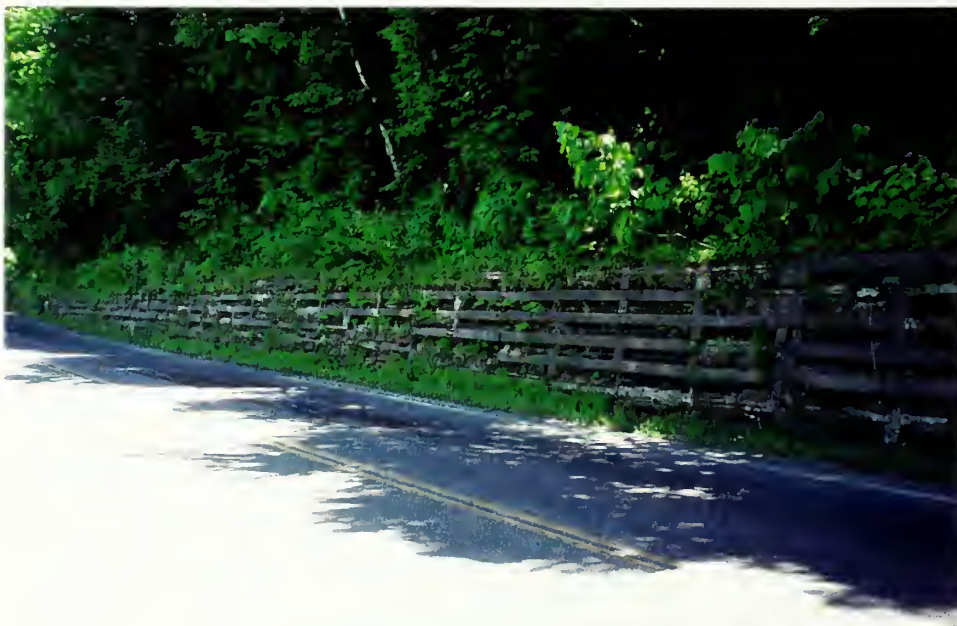
Mile Marker 43.1 Russell/Huntington

Located at mile marker 43.1, on the western side of Jacob's Ladder Trail, this concrete crib wall ranges in height from four to seven feet and is approximately 415 feet in length. It is an unsightly, dilapidated structure which is in poor condition along its entire length. On the east, this wall abuts a stone wall that is to remain. At the junction of the two walls, the concrete members of the crib wall appear to be in very poor condition. Large portions of concrete have spalled off. At the spall locations, exposed steel reinforcing is significantly rusted and there are a few broken bars. The backfill material

is nonexistent. Proceeding westerly, the wall continues in a similar state. Most exposed elements are severely deteriorated with rusted steel reinforcing bars protruding through the concrete. This has also caused staining of the concrete. One portion of the wall has experienced horizontal and vertical movement. Elements are completely crushed or broken into fragments. At the west end of the wall, the backfill material has also eroded to the degree of being nonexistent. In addition to the questionable stability of the wall, its abrupt ending is not acceptable to Massachusetts Highway Department standards.

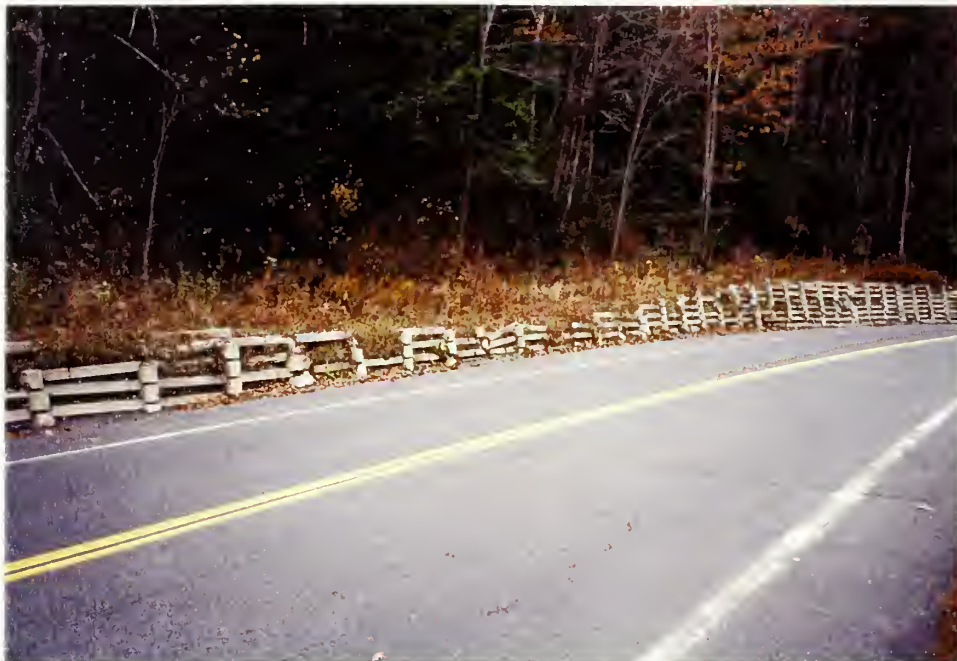
Mile Marker 34.0 Chester

Located at mile marker 34.0, on the western side of Route 20, this retaining wall is in poor condition. It ranges in height from three to seven feet and is approximately 375 feet in length. On the southerly end of the retaining wall, the entire unit is exposed on three sides. This exposure indicates that the structure is unnecessary. Rocks and boulders are present in this area. The wall has some missing elements, the majority of the members are severely deteriorated and several pieces are cracked and broken. Portions of the members have exposed steel reinforcing bars, which are severely rusted. A few members have also rotated forward and appear to be falling. Members have collapsed, causing
